**INVESTIGATION OF REASONS AND POSSIBILITY OF PARAMETERS ELIMINATION
INFLUENCING CRACKING OF LEAF SPRINGS ON CONTINUOUS CASTING MACHINE**Received - Primljeno: 2006-04-20
Accepted - Prihvaćeno: 2007-04-15
Preliminary Note - Prethodno priopćenje

At the first look very simple and for several hundred years used elastic element can be critical part in complex equipment where its failure invokes extraordinary high losses. In the paper is given a treatment for the solution of this problem by experimental methods and resulting proposal for its final solution.

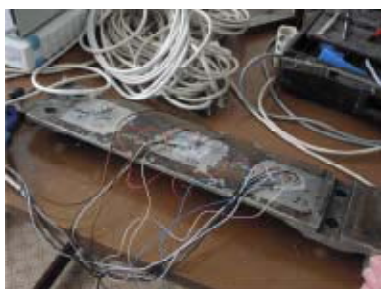
During solution of this problem the residual stresses in broken leaf spring were determined by the hole drilling method. Strain gages for the hole drilling method can be seen in Figure 2.

The maximal level of residual stresses (pressure) does not exceed 40 MPa.

Figure 2. Locations of strain gages RY 61 for the hole drilling method
Slika 2. Lokacije tenzometra RY 61 za metodu bušenja rupe

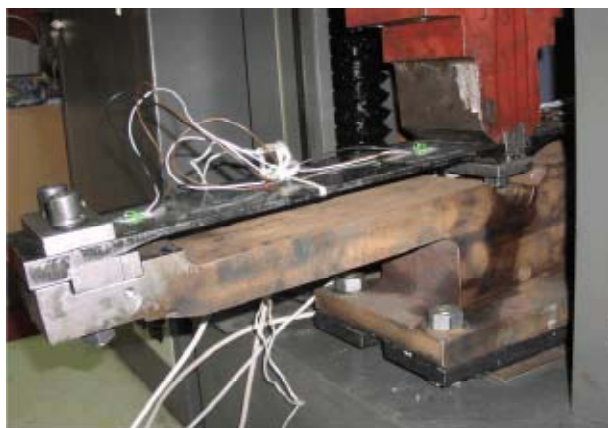
Figure 3. Leaf spring with applied strain gages in tensile machine
Slika 3. Lisnata opruga s primijenjenim tenzometrom u stroju za mjerenje otpora na istezanje

Strain gage measurements of stresses in leaf spring were realized for fastened spring ends and prescribed vertical deformation of leaf spring in tensile machine. In

order to provide the measurements on leaf springs in the tensile test machine it was necessary to use holding fixture because leaf spring is not in horizontal position and axial component of force should cause shifting of spring from pedestal of tensile machine. Fastening of holding fixture together with leaf spring is given in Figure 4.

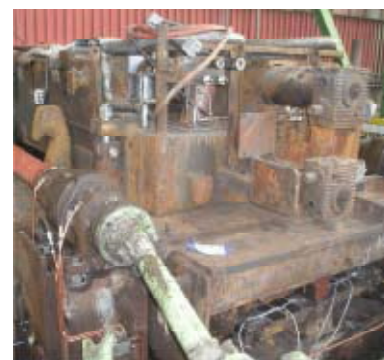
The stress measurement of springs in the frame of equipment for continuous casting of slabs was realized after calibration in

Figure 5. Leaf spring positioned in frame
Slika 5. Lisnata opruga pozicionirana u okviru

tensile machine and after positioning of springs into the frame (see Figure 5.).

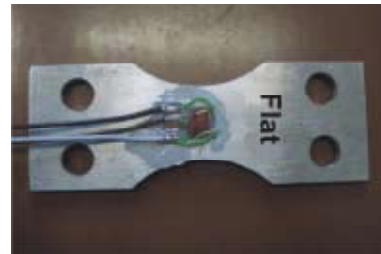
On the flat surfaces of specimens 1 to 3 were applied in the most narrow cross sections the strain gages 1-XY91-10/120 with gage factor $k = 2,05$ and resistance 120 Ω . The grid of the strain gage perpendicular to the axis of the specimen is used for thermal compensation and at the same time in the sense of Hooke's law it comprises also influence of transversal deformation. Specimens 2 and 3 were chosen such a way that they have stress concentrator in the most narrow part of the specimen's cross section. In Figures 9. to 12. are shown specimens 1 to 3 taken from positions of leaf spring according to Figure 8.

Figure 10. Specimen 2 for fatigue test taken from the flat part of spring
Slika 10. Uzorak 2 za test zamora materijala uzet iz plosnatog dijela opruge
